REPLACING THE PHOTOCONDUCTOR

CS921, CS923, CS927, CX920, CX921, CX922, CX923, CX924, and CX927

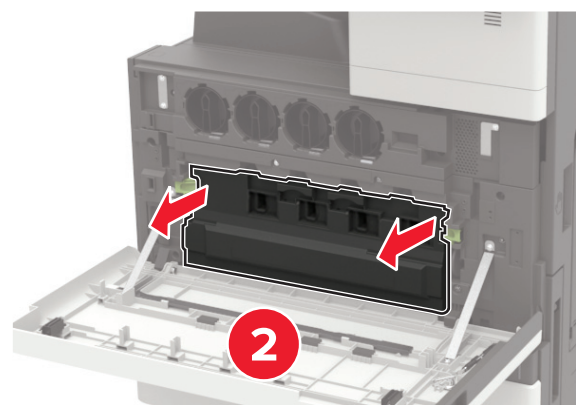
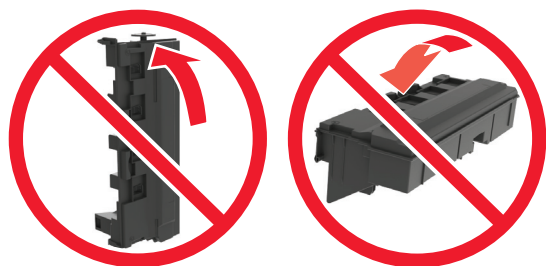
01

Open door A. Remove the waste toner bottle.

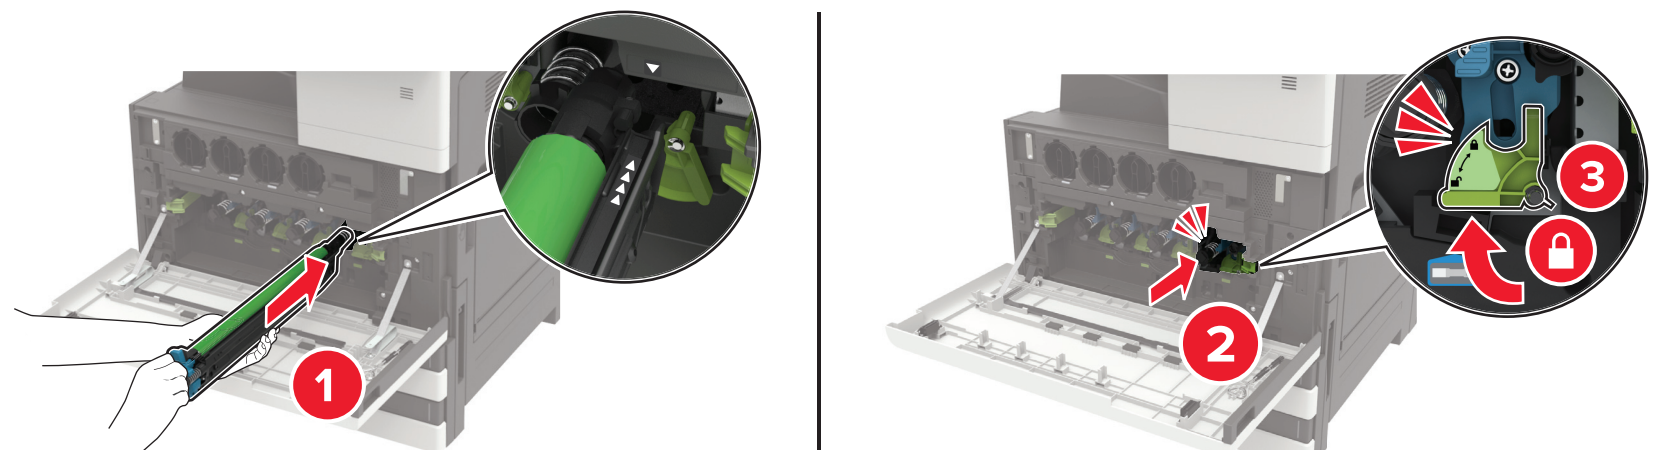
03

Warning—Potential Damage: Do not expose the photoconductor unit to direct light for more than one minute. Extended exposure to light may cause print quality problems.

Warning—Potential Damage: Do not touch the photoconductor drum. Doing so may affect the quality of future print jobs.

Insert the new photoconductor unit.
